**Resilience works:** Home retrofitted

**Typology:** High-set elevated, lightweight framing which has been built under

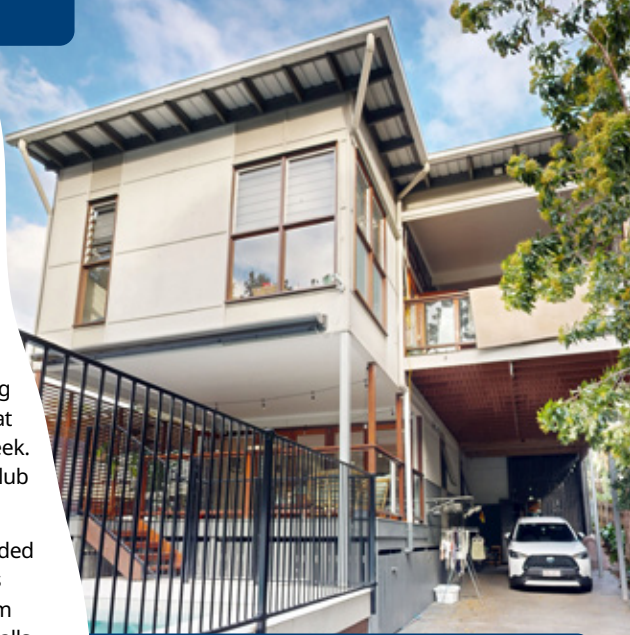
The hardwood timber floors didn't need to be replaced. Her kitchen was built back with marine ply, double two-packed for water resilience. The kickboards are removable, meaning they can be taken off before or after a flood event and the area hosed out easily.

The existing pine frame cavity walls were painted to help with future cleaning and prevent mould growth, her doors are now solid core.

The bathroom is a beautiful space with floor to ceiling tiles — the same tiles that are around the pool. The vanity unit is suspended on stainless steel legs.

Raising the lift control panel from downstairs to the upstairs space where her son and his family live was probably the most significant flood-resilient improvement made.

“We treated the bathroom like a swimming pool — with the tiles, adhesives and epoxy grout all water-resistant,” says her builder Steve, of Arlidge Constructions.

“In her case, as well as being resilient it had to be functional for her. It's all custom built and resilient, so if a flood comes it should just be a matter of hosing the water out.”
